BY MICHAEL CHUSID & JENNIFER MORGAN

# Standing Ready

## *Lightning protection for hospital rooftop gardens, terraces*

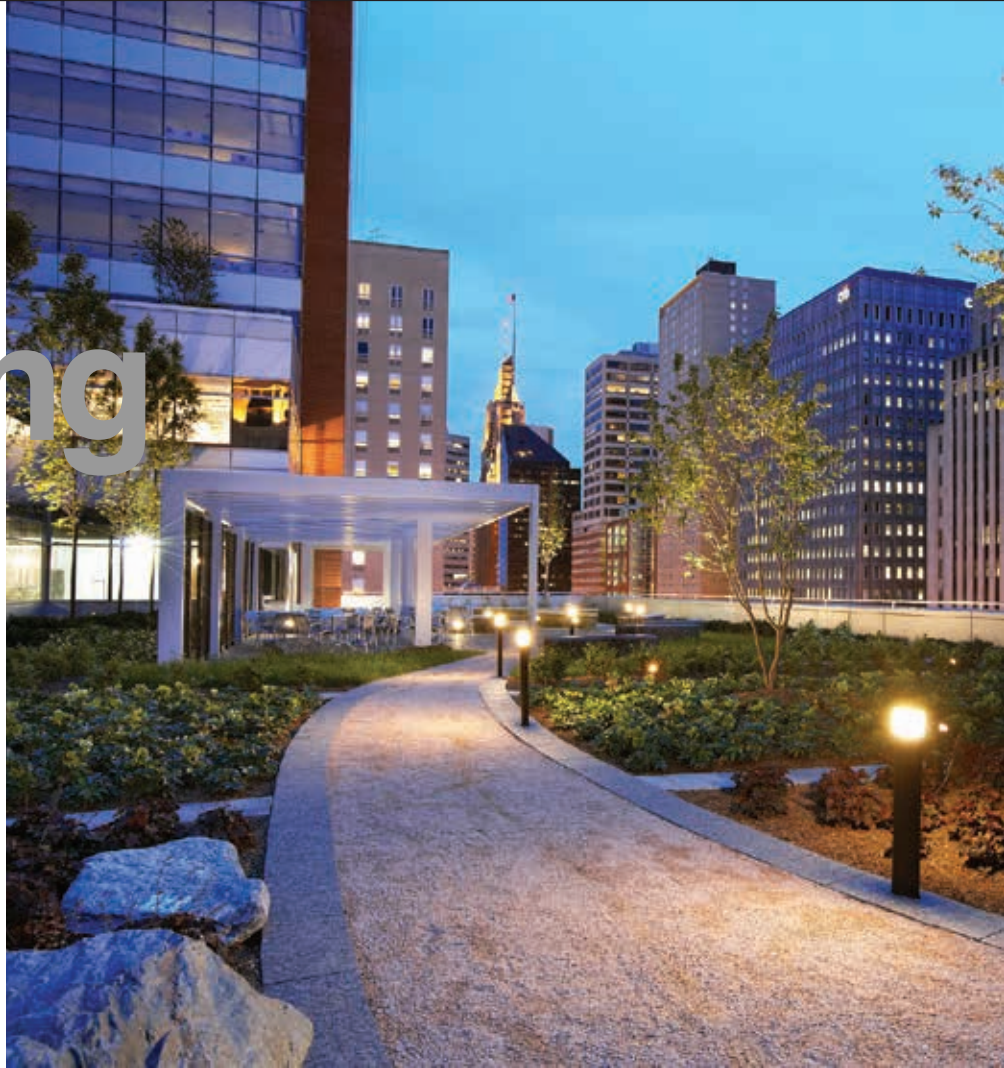
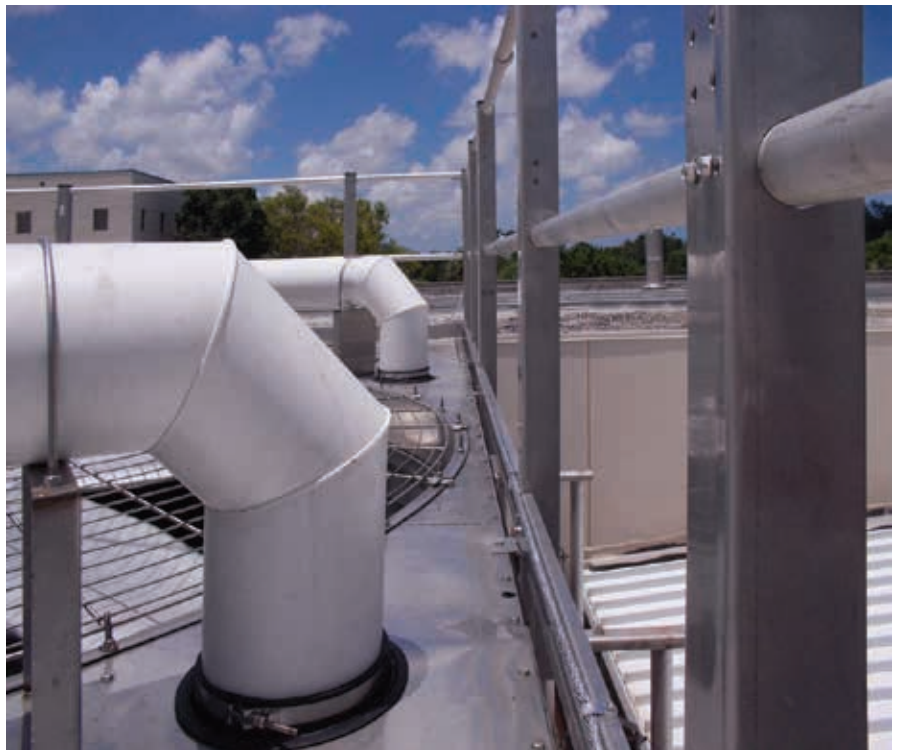
**STRIKE ZONE** At Mercy Medical Center in Baltimore, Maryland (top), both the open-air pavilion in this rooftop garden and the metal handrails (on the right in photo) are used as strike termination devices in accordance with nationally recognized standards. The railing is elevated above the parapet so lightning will attach to it instead of the masonry. > Kendall Regional Hospital in Florida has, perhaps, a more typical hospital roof. Yet even this "garden" of equipment has to be made part of the lightning protection system. Since the guardrails on this raised platform rise above the equipment, they are bonded to the lightning protection cable seen around the perimeter of the platform and used as strike termination devices.

In another project, many people actually visit the roof gardens and terrace at Mercy Medical Center in Baltimore, Maryland. It is built on three levels and includes a shade structure made from steel. Masonry parapets at each roof level are topped with a stainless steel handrail that has been made electrically continuous with ground. The shade structure also serves as a strike termination device and is connected to ground.

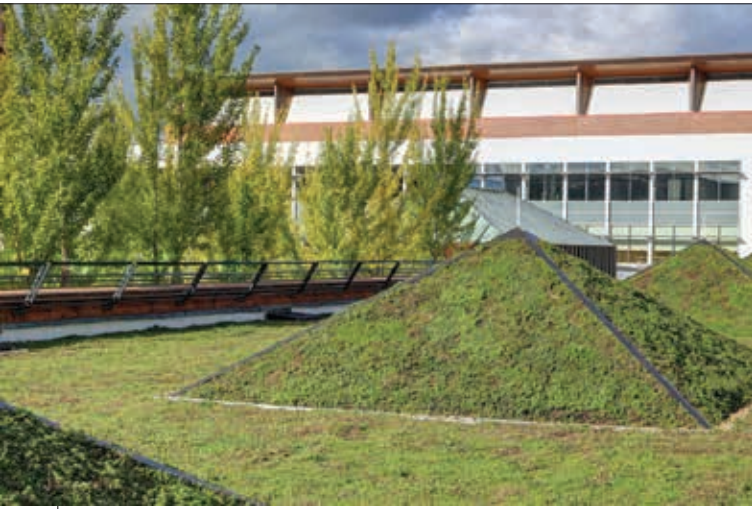
**GROUND DOWN** At University of Virginia Hospital, steel railings are made electrically continuous and connected to lightning protection cables that lead to ground. Conventional air terminals are also used at the top of the landscaped “mountains” and on the rest of the building where it was not practical to use railings as strike termination devices. (Below) Mounted on a masonry parapet around the vegetated roof, the railings were bonded to the lightning protection grounding system. Copper jumper cables were utilized between sections to make the span electrically continuous.

Conventional air terminals could be used because patients do not have access to the roof. On some of the parapet walls, however, a steel railing was used as a strike termination device. Copper conductor cables are used as jumpers between sections of railing to create electrical continuity. Other conductors interconnect all components of the lightning protection system; they were laid on the roofing membrane, and then covered with the green roof.

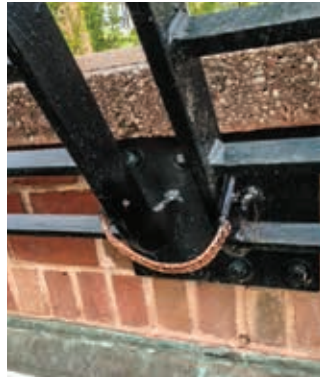
Utilitarian structures on regular roofs can also be used as strike termination devices — either for convenience or cost savings. At Kendall Regional Hospital in Florida, for example, a metal walkway was installed as a platform for servicing rooftop equipment. The railings around the walkway are interconnected

with the lightning protection system and grounded.
